The Vicar's Pele, Corbridge, Northumberland, NE45 5AW

Report on the excavation of an Archaeological Test Pit

On behalf of Spence & Dower LLP

Northern Counties Archaeological Services, July 2014

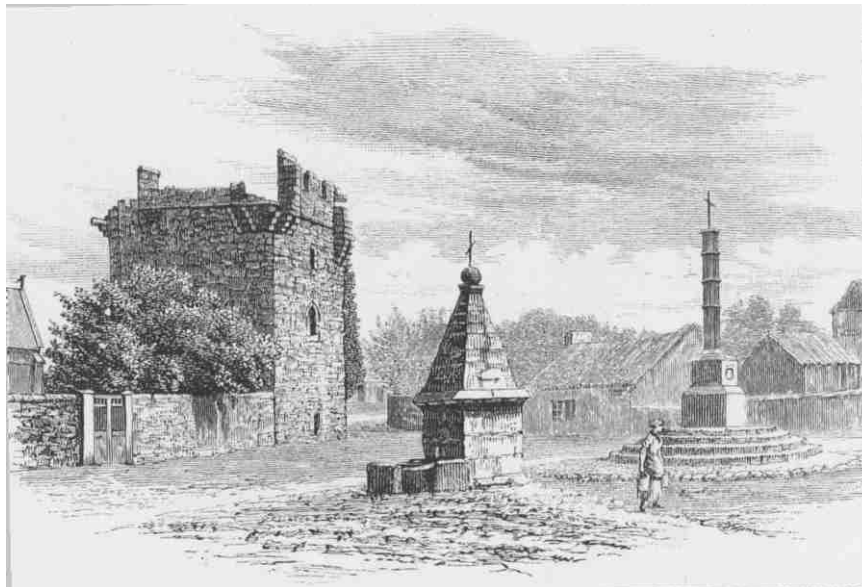
*Figure 3. The Pele and market place looking north-east by W.J.Palmer, published in 'The Tyne and its Tributaries' (1882).*

- 5.4 A map of Corbridge by John Fryer, made 1776-7, shows cottages adjoining the west wall of the Pele, and both the Pele and the cottages standing outside the churchyard. Mackenzie's History of Northumberland, published in 1825, states that the sites of these 'old houses' had been bought by the parishioners and added to the churchyard. This latter arrangement is shown on an unattributed and unreferenced illustration reproduced by Dixon (Figure 2), who dates the view to 1819, and also appears on the 1860 Ordnance Survey map and an illustration of c.1882 (Figure 3).

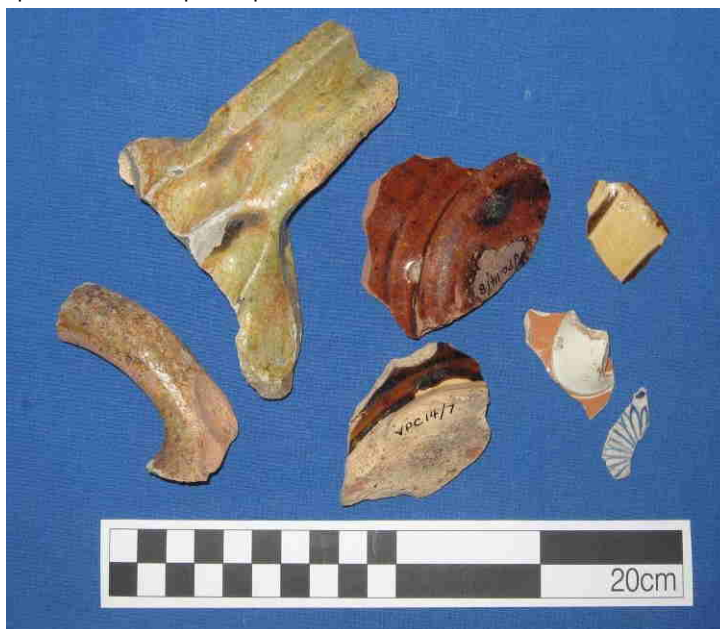
Figure 4. Top left: 13<sup>th</sup>14<sup>th</sup> century strap handle and (below) possibly early 14<sup>th</sup> century rod handle. Centre top: brown glazed red earthenware base and (below) possible Staffordshire mug base, both probably 18<sup>th</sup> century. Top right: slipware mug rim, possible 18<sup>th</sup> century; centre right: teapot spout, first half of the 19<sup>th</sup> century; Below right: refined glazed white earthenware with painted decoration, possibly late 18<sup>th</sup> century.

Twenty-seven sherds were recovered, all from post-medieval contexts <7>, <8>, <14> and <16>. Contexts <14> and <16> each produced twelve sherds. Most were early glazed ware body sherds of the mid-late 13<sup>th</sup> century. There was also a buff sandy strap handle (context <8> ( Figure 4) and a reduced greenware rod handle rod-handle (context <7>) both from jugs, which could be as late as the early 14<sup>th</sup> century. Although all the medieval pottery occurred residually in post-medieval contexts, the quantity and cleanly broken edges suggest this material derived from disturbance to medieval deposits within the basement. This suggestion is supported by the complete absence of medieval pottery from the obviously imported demolition deposits above the possibly disturbed floor level <7>. The date range of the pottery suggests that the deposits or features containing the pottery may pre-date construction of the Pele.

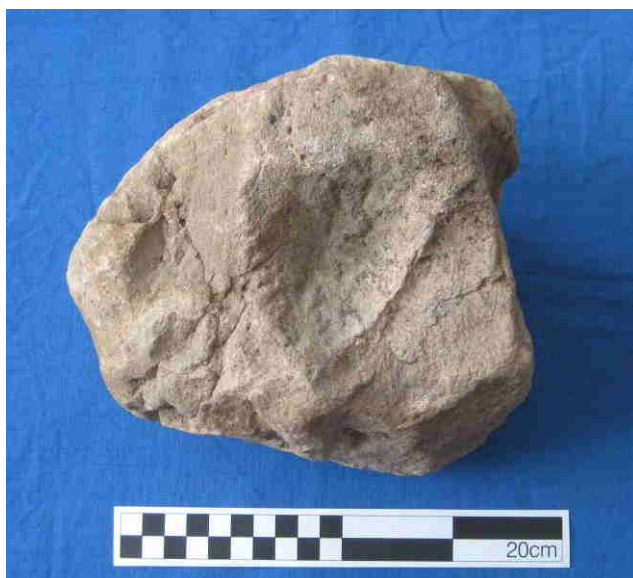
A prehistoric cup-marked stone came from context <7>. Fine-grained, pale red sandstone, roughly triangular with a rounded base (145mm by 175mm). On the flatter, upper, surface is a damaged 'cup' originally c.80mm diameter and c.30mm deep, with shallow tapering sides showing clear pecks and grooves. The rounded base suggests re-use, inverted, in a cobbled surface. This is an example of 'portable' rock art, broadly datable to the late Neolithic – Early Bronze Age (Peter Topping *pers. comm.*). It is possible this formed part of a floor surface within the basement of the Pele, and arrived on the site with other stone robbed from the Roman site at Corstopitum, where a cup-marked stone is incorporated into the part of the foundations of the 4<sup>th</sup> century workshops [HER 9043].

Figure 5. Cup-marked stone from context <7>, showing damaged cup with tooling marks. Scale 20cm

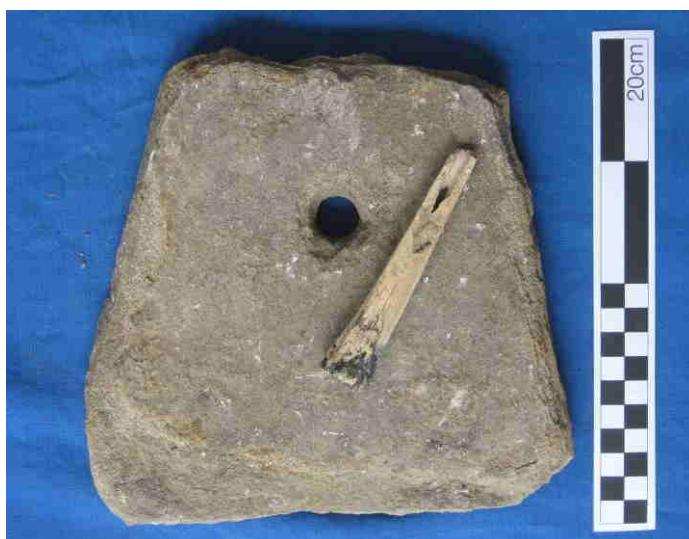
Numerous fragments of grey-brown sandstone roof flags (tiles) ranging in thickness from 18mm-25mm were found in demolition contexts <5> and <6>, associated with sheep *metapodials* used as pegs to hang the slates on the rafters (see Faunal remains). These are not uniquely datable, but as true 'slate' (Welsh, Cumbrian, Scottish, and West Country) only became common for roofing in the 19<sup>th</sup> century, the stone flags could be of similar date to the wrestler. Samples of flag fragments with either peg holes or measurable dimensions were retained.

Figure 6. Stone roof flag (broken) with sheep metapodial 'peg' and peg hole, from context <6>.

The majority of the faunal remains from contexts <5> and <6> are sheep metapodial bones, which had been used as pegs to hold stone roof slabs in place. Several examples were found still *in situ* in roof slabs. Only the proximal ends of the bones had been used for this purpose, the distal ends had been routinely chopped off. The exposure to the elements and the acidic nature of the sandstone roof slabs has initiated decay in these bone pegs with surface degradation and crushing of the shafts from the weight of the slabs, with associated splitting and splintering of the shafts.

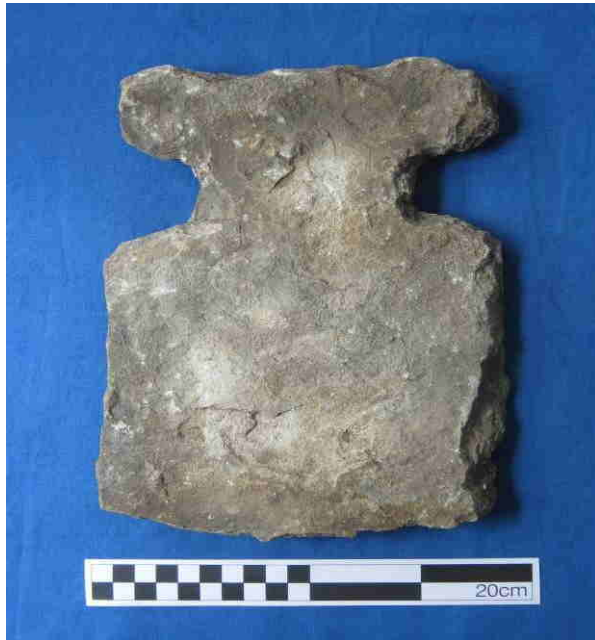
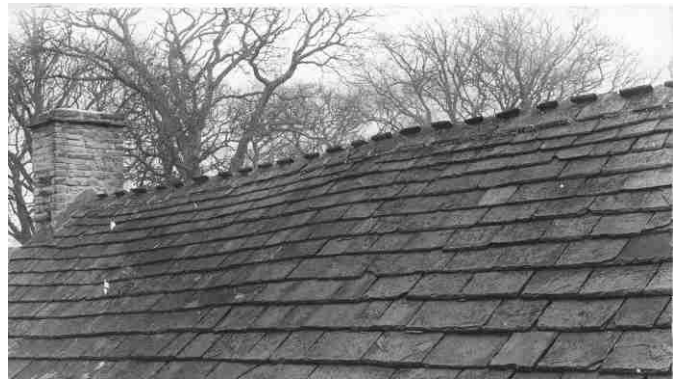
A 'wrestler' roof-ridge flag, in fine-grained grey sandstone (L260mm, W175mm, T30mm), came from context <6>. The notches allowed the flags to interlock when laid on alternating sides of the ridge, forming a secure ridge-line with a 'cock's comb' appearance (see Figure 7). Wrestlers or Jack-necks are known from late 16<sup>th</sup> century and 17<sup>th</sup> century contexts in Newcastle, and have been recorded on standing buildings in the south of Northumberland and north Co. Durham [Harbottle and Ellison, 173-4].

Figure 7. Left: a 'wrestler' tile from context <6> showing the notches where the tiles interlocked. Above: 'wrestlers' *in situ* forming a roof-ridge, with stone flags of graduated sizes.

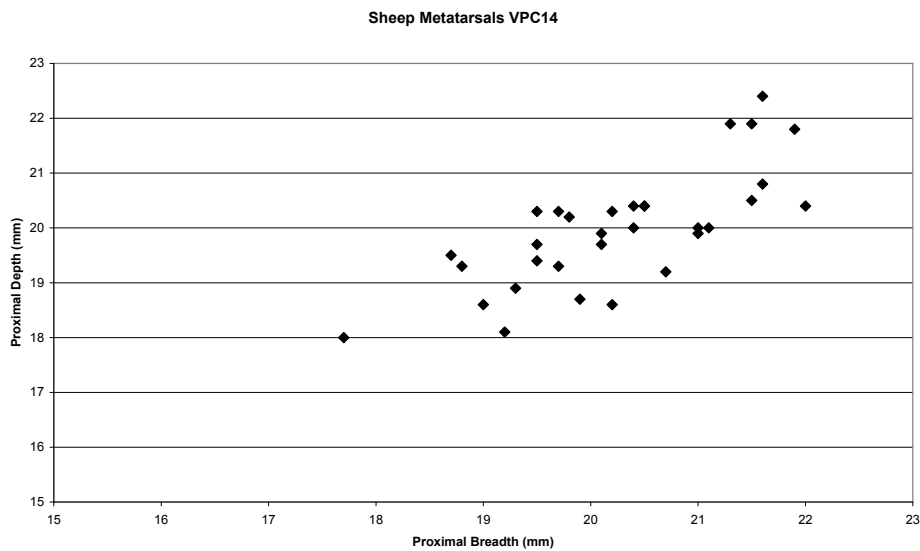
The proximal metapodials do not have a separate epiphysis for estimates of age from fusion and all the distal ends have been removed, so there is no ageing information for this slaughter population. Measurements of the proximal ends can be difficult to interpret as both the sex ratio and age range of the animals represented are unknown. However, since this is all the information available for comparison, Figure 8, below, shows the size range of the proximal metatarsals.

Figure 8. Size range of sheep proximal metatarsals used as pegs for roof flags.

Simplistic interpretations of such graphs as depicting sex ratios has been shown to be flawed [Sykes & Symmons 2007, Gidney 2013]. However, such graphs can show the size range of the bones selected for this specific purpose, compared to a broader population.

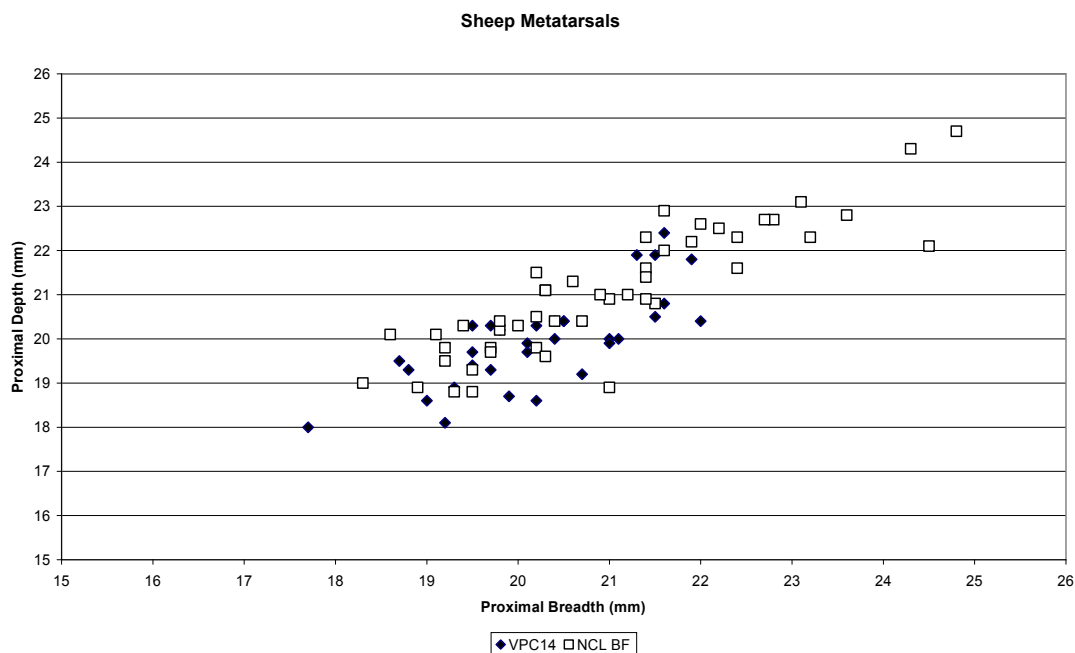
Figure 9, below, compares the VCP14 finds with examples from the Black Friars at Newcastle, of later 17th to early 18th century date [Rackham 1987]. The reason for the deposition of this large group of sheep metapodials is unclear but one possible explanation is that they were the dumped surplus of bones acquired for roof pegs. Only the complete bones with the distal end fused were measured. It can be seen that the VCP14 distribution overlaps the lower end of the Black Friars range but lacks the large examples seen at Black Friars. Given that the broader metacarpal bones at VCP had to be modified to fit the holes in the stone slabs, it is possible that the larger bones seen at Black Friars would have been unsuitable for roof pegs at Corbridge, although both assemblages may represent the same local sheep population.

Figure 9. Comparison of sheep metatarsal sizes from the Vicar's Pele (VPC) and Black Friars, Newcastle.

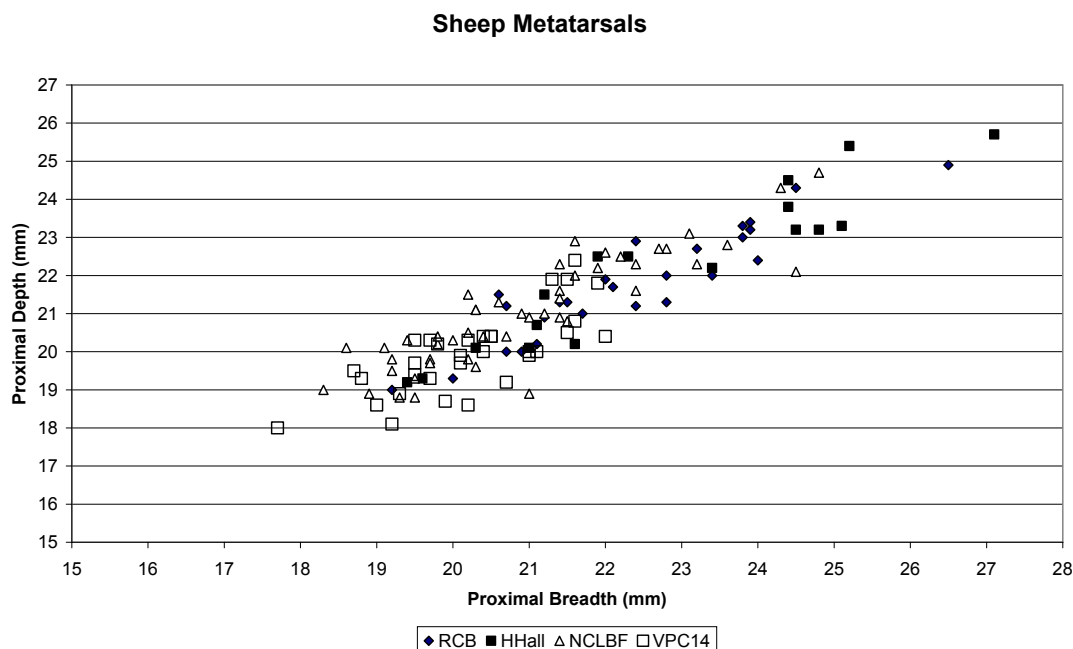
Figure 10, below, compares the Hamsteels Hall and Richmond data with VCP and Black Friars. It can be seen that bone pegs with much larger proximal ends than the VCP examples were used at both Hamsteels Hall and Richmond. This raises intriguing questions about the availability of sheep metapodials to make these roofing pegs, and the size of the animals compared to the size of the holes in the roof slabs. While this site has produced a further useful sample of metrical data for these bone pegs, it is now becoming apparent that similar data on the size of the holes in the roof slabs is necessary to put such data in context.

Figure 10. Comparison of sheep metatarsal sizes from Hamsteels and Richmond with those from the Vicar's Pele and Black Friars, Newcastle.

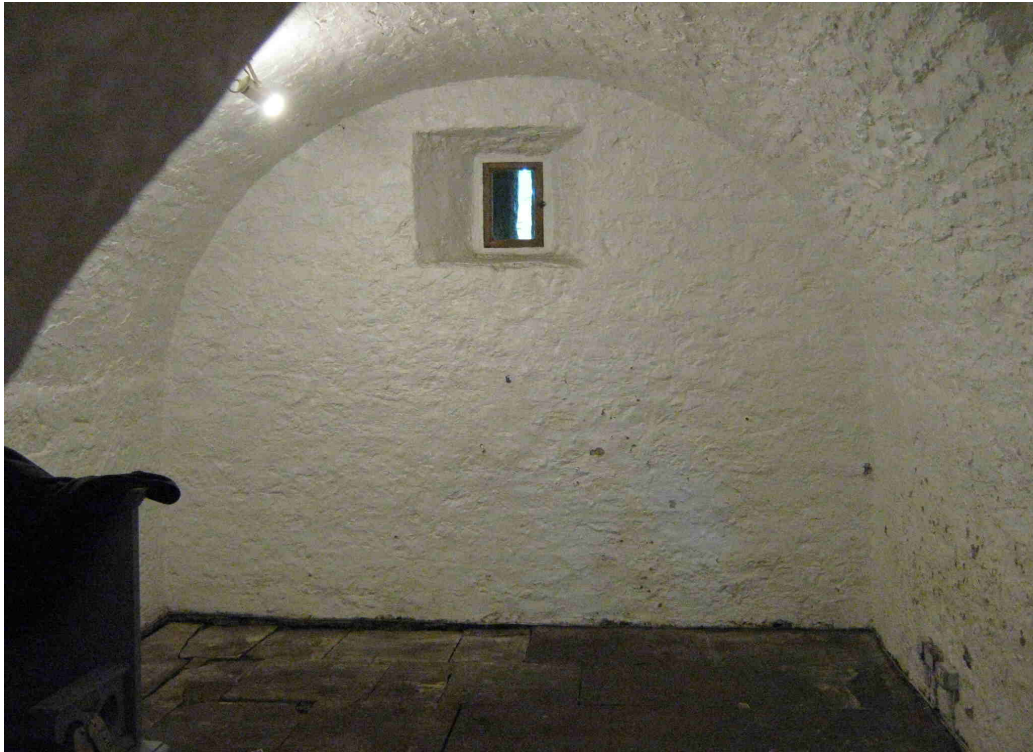
Plate 1. Interior of the vaulted basement of the Pele looking west, showing a loop hole. The Test Pit was excavated in the left-hand (south-west) corner.

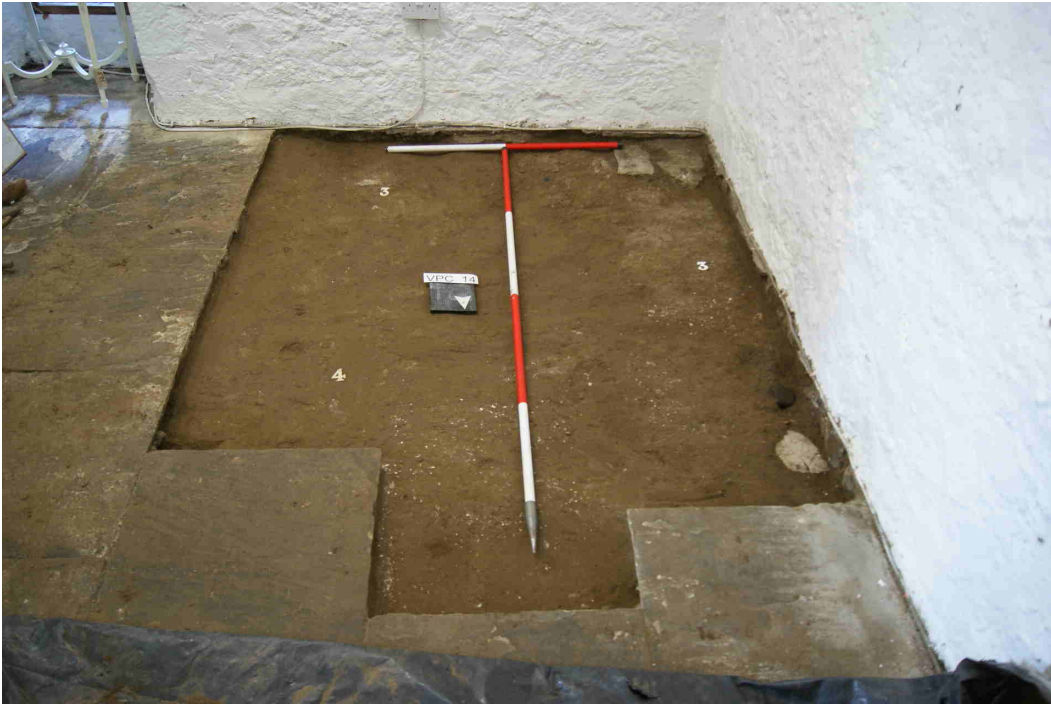
Plate 3. After removal of paving <1> and sand bedding <2>, showing mortar patches <3>, possibly from a floor pre-dating the 1910 restoration, and context <4>. Scales 2m and 1m.

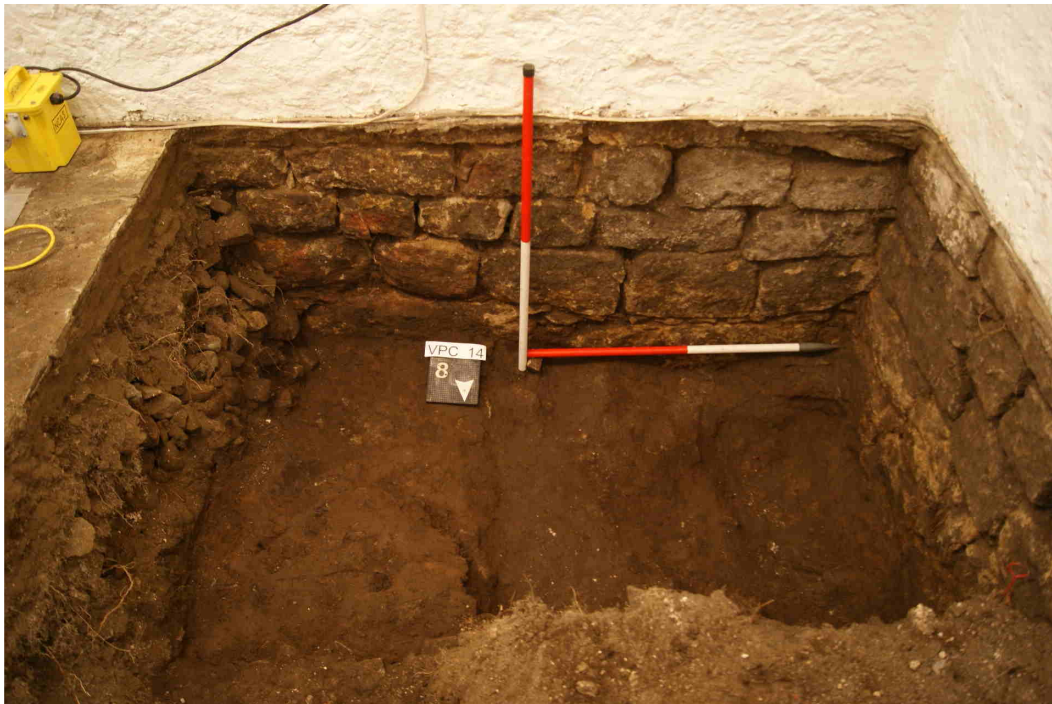
Plate 5. After removal of possibly disturbed floor level <7>, showing context <8> and cut <14> beginning to emerge in the south-west corner. Scales 1m.

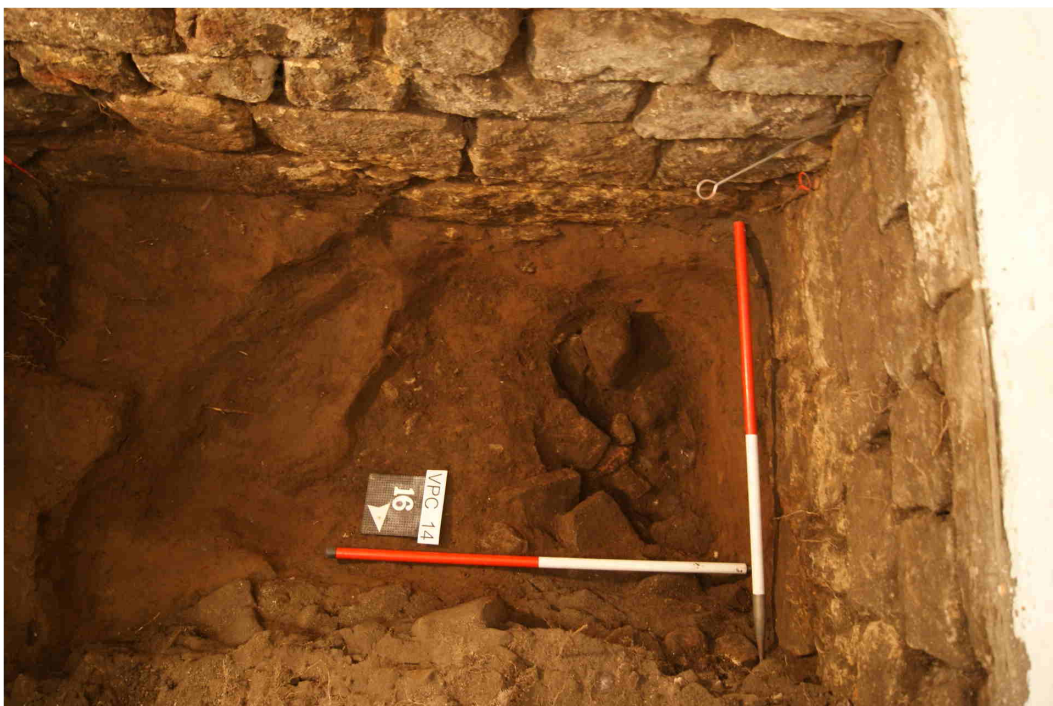
Plate 6. Context <16> in cut <9>. Truncated natural alluvial sand <10> is visible top left (see Figure 13). Scales 1m.

- 8.4 The cut feature <9> appeared to be a large pit dug within the south-west angle of the basement and infilled possibly in the 19<sup>th</sup> century. Filling the cut, contexts <8>, <14> and <16> consisted of moist dark brown soil with frequent inclusions of sandstone rubble, including broken pieces of roof flags, some hand-made brick, a piece of clay tobacco pipe stem and pottery ranging in date from medieval to the first half of the 19<sup>th</sup> century. The cut itself may represent the robbing of stone or brick-lined feature – such as a cess pit, or even a well. A cess pit may have been provided when the basement was apparently restored for use as 'lock-up' prior to 1825 [Mackenzie, 327].

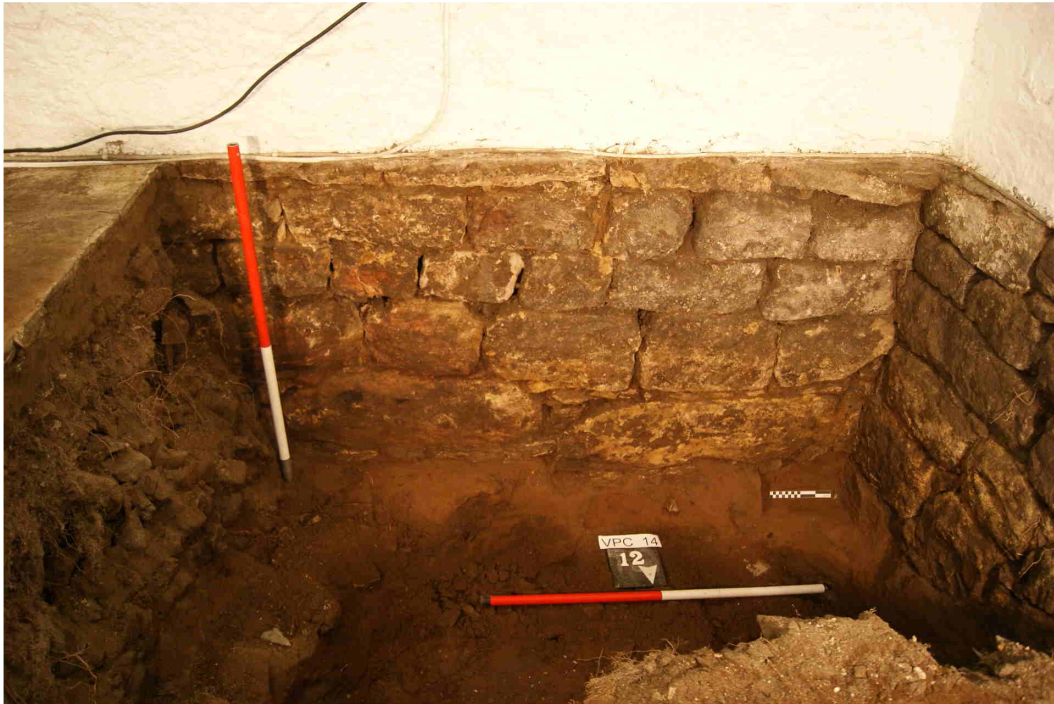
Plate 7. Inner face of the south wall of the Pele, showing base course and small underlying stones in truncated construction cut. Scales 1m.

- 9.2 The visible base course of the ashlar face of the south wall is not level, masonry varying between 40.57m and 40.68m OD in depth (approximately 0.88m to 1.00m below internal paving surface). The wall was founded in a cut in the natural sandy clay, the original depth and width of which could not be determined.

- 9.4 There is some evidence for burning on the south wall face, but due to post-medieval disturbance within the Test Pit area there were no associated datable deposits or *in-situ* artefacts which might link this with known 14<sup>th</sup> century Scottish incursions.

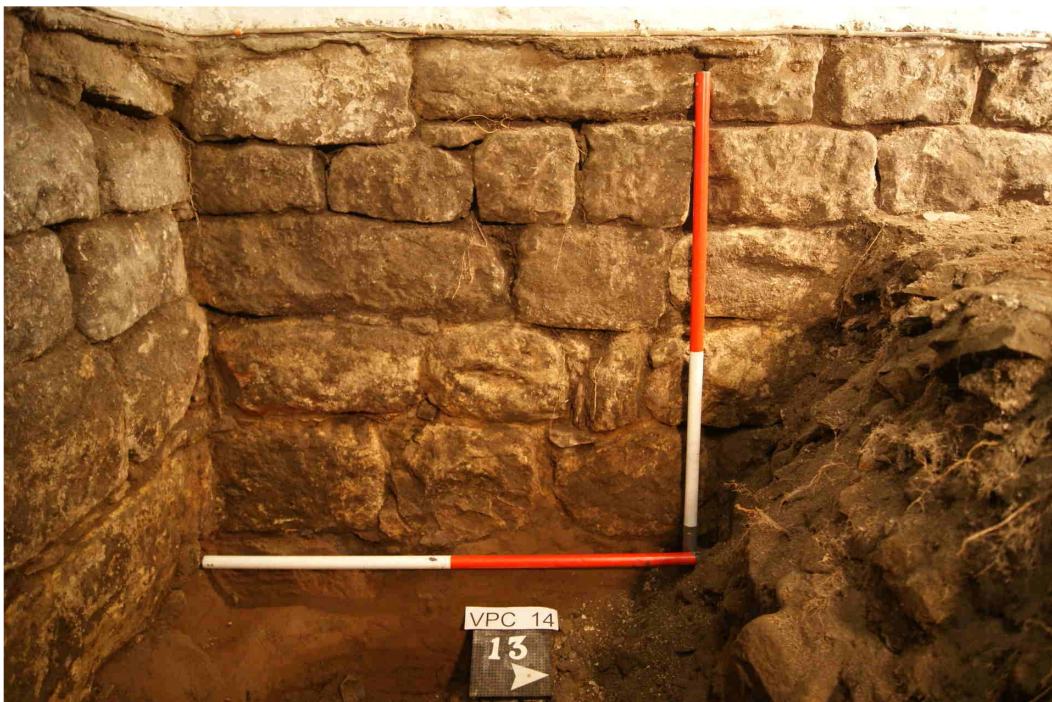
Plate 8. Inner face of west wall of the Pele <13> and junction with south wall <12>, showing base course resting on natural alluvial sandy clay and possible construction joint (see Figure 14). Scales 1m.

- 7.3 There was no internal offset or foundation raft. Some thin slabs of sandstone were visible immediately below the base course of ashlar at between 40.45m to 40.66m AOD, lying at an angle presumably dictated by the dished base of the foundation cut. In the south wall, the exposed base course comprised two large sandstone ashlar 0.7m – 0.8m in length, the easternmost laid at a higher level than the other. On the west wall the exposed base course comprised two smaller, squared blocks at the angle, and an irregular stone to the north: at this point there was some suggestion of a vertical joint in the masonry above (see Figure 14 and Plate 8).
